Browns Ferry Nuclear Plant, Unit 3
Renewed Facility Operating License No. DPR-68
NRC Docket No. 50-296

Subject: **Licensee Event Report 50-296/2014-001-00, Automatic Reactor Scram
due to a Turbine Trip on High Moisture Separator Level**

Licensee Event Report 50-296/2014-001-00

Automatic Reactor Scram due to a Turbine Trip on High Moisture Separator Level

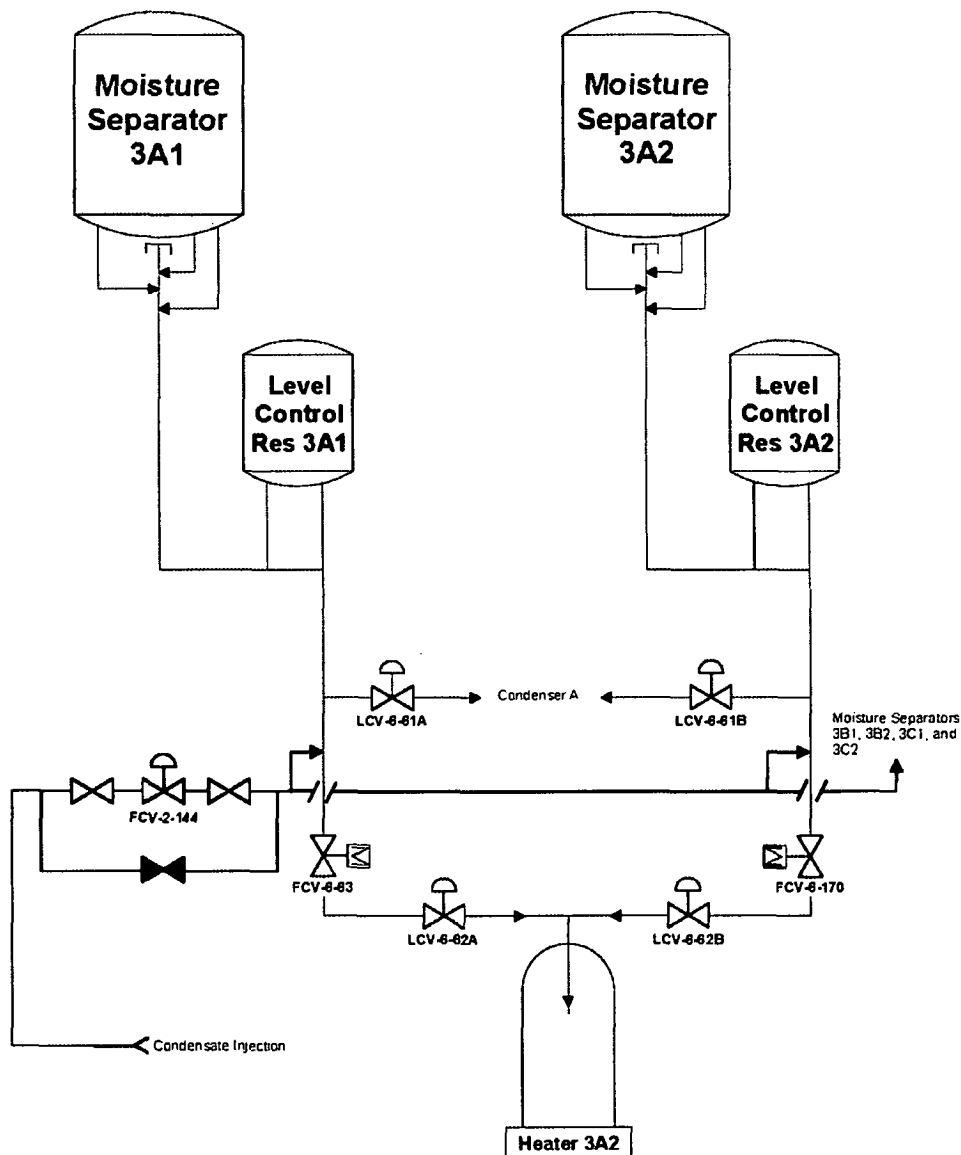
Figure 1 shows the drain [DRN] system for Moisture Separators 3A1 & 3A2. The drain systems for Moisture Separators 3B1 & 3B2 and 3C1 & 3C2 are similar.
